Inspection

Inspector: David Rowe

PROPERTY INSPECTION REPORT

8/15/2019

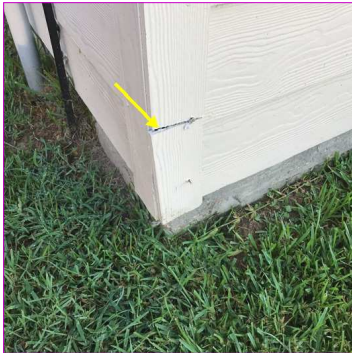
The cementitious lapped siding had localized areas of damage. To prevent damage to home materials or the wall structure from moisture intrusion the Inspector recommends repair by a qualified contractor.

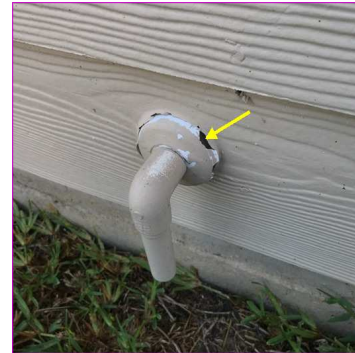
Pipes penetrating exterior walls left gaps that needed to be sealed with an appropriate sealant to prevent moisture and insect entry. All work should be performed by a qualified contractor.

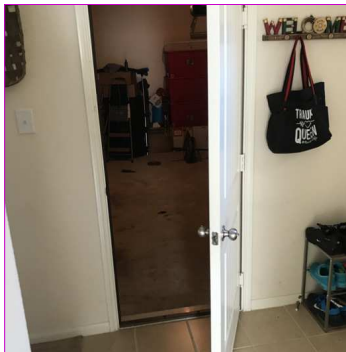
Door leading to garage not equipped with self closing hinges. I recommend installation by a qualified contractor

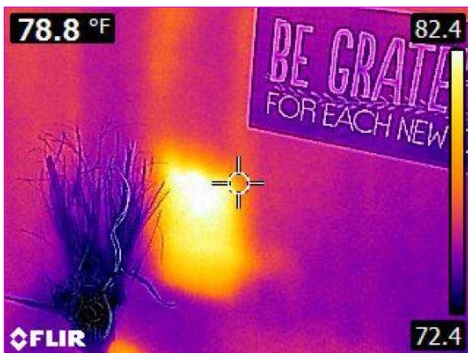
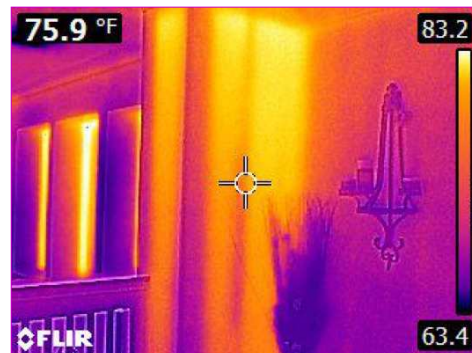
- Thermal imaging indicated that insulation in the exterior walls is missing on one or more areas. These areas will experience greater heat movement through the walls than portions of the walls with intact insulation. This condition will increase heating and cooling costs. I recommend further evaluation by a qualified contractor
- First picture was of the wall on the stairway landing.
- Second picture was taken in the upstairs living room.

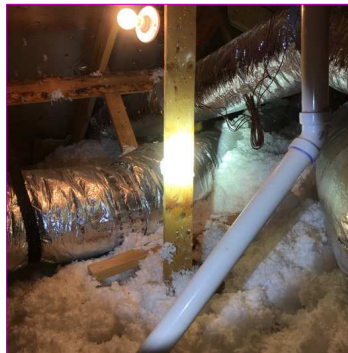
Ductwork laying on the floor. This could cause condensation between the duct and the insulation. The ducts need to be hung from the rafters straps every 2 to 4 feet.

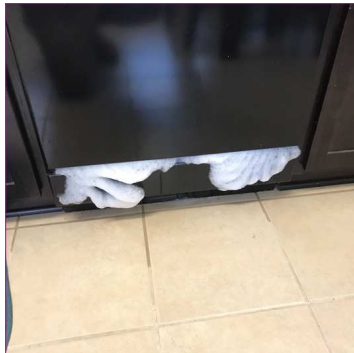
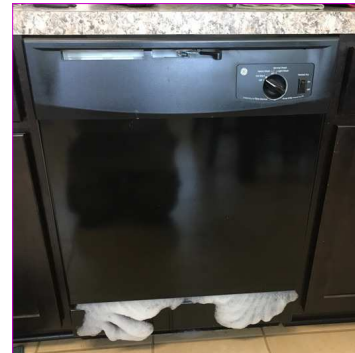
During operation the dishwasher leaked water onto the floor.

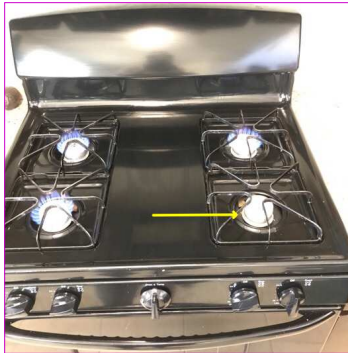
One or more rangetop burner igniters failed to ignite a gas burner.

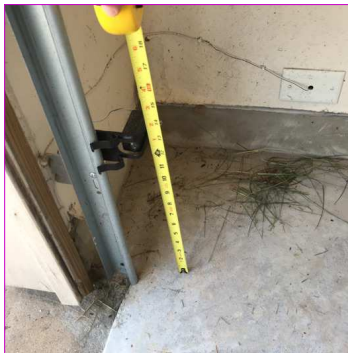
- An overhead garage door photo sensor was installed at a height greater than 6 inches above the floor. Photoelectric sensors are devices installed to prevent injury by raising the vehicle door if the sensor detects a person in a position in which they may be injured by the descending door. Installation of photo sensors in new homes has been required by generally-accepted safety standards since 1993. Safety standards designed to protect small children limit the maximum mounting height for garage door photo sensors to 6 inches. The Inspector recommends correction by a qualified garage door contractor.

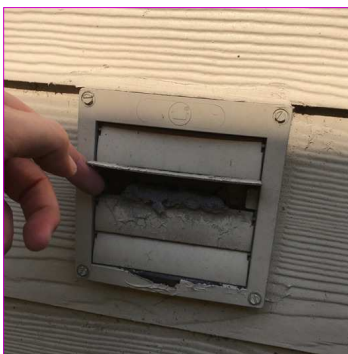
The dryer vent exterior outlet had excessive lint build-up. This can lead to clogging of the dryer vent and overheating of the dryer, which are potential fire hazards. The Inspector recommends that the dryer vent termination be cleaned or replaced. All work should be performed by a qualified contractor.
