Inspection

Inspector: David Rowe

PROPERTY INSPECTION REPORT

8/15/2019

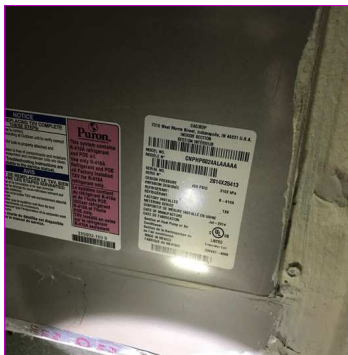
- This furnace was manufactured by Carrier.
- At the time of the inspection, the Inspector observed no deficiencies in the condition of the gas supply at this furnace.
- The thermostat for this furnace was located in the hallway, upstairs hallway.
- Outside ambient temperature too high to test the heater in heating mode.

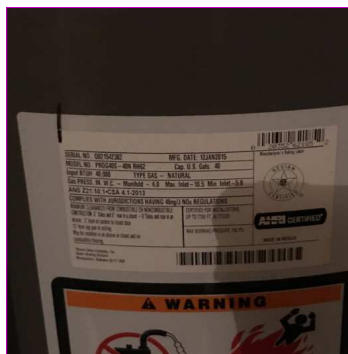
- The water heater was manufactured by Rheem.
- Water heater is located in the garage
- At the time of the inspection, the Inspector observed no deficiencies in the condition or operation of the water heater.

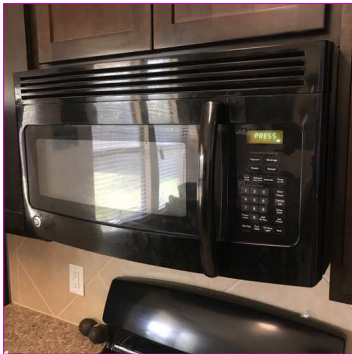
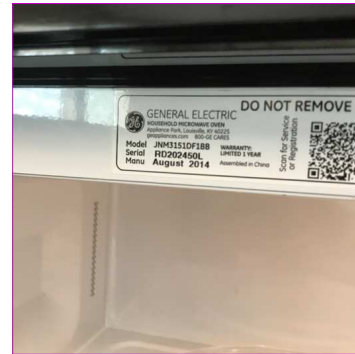
- At the time of the inspection, the Inspector observed no deficiencies in the condition and operation of the built-in microwave oven. Built-in microwave ovens are tested using normal operating controls. Unit was tested and appeared to be serviceable at time of inspection. Leak and/or efficiency testing is beyond the scope of this inspection. If concerned, you should seek further evaluation by qualified technician prior to closing.
